DEPARTMENT OF TRANSPORTATION**DIVISION OF ENGINEERING SERVICES**

Contract #: 04-0120F4Cty: SF/ALA Rte: 80 PM: 13.9/14.3,0.0/1.6File #: 69.28**WELDING INSPECTION REPORT****Resident Engineer:**Pursell, Gary**Address:** 333 Burma Road**City:** Oakland, CA 94607**Report No:** WIR-000858**Date Inspected:** 14-Nov-2007**Project Name:** SAS Superstructure**OSM Arrival Time:** 630**Prime Contractor:** American Bridge/Fluor Enterprises, a JV**OSM Departure Time:** 1530**Contractor:** Zhenhua Port Machinery Company, Ltd (ZPMC), Changxing Island **Location:** Shanghai, China**CWI Name:** Cui Ri Yu**CWI Present:** Yes No**Inspected CWI report:** Yes No N/A**Rod Oven in Use:** Yes No N/A**Electrode to specification:** Yes No N/A**Weld Procedures Followed:** Yes No N/A**Qualified Welders:** Yes No N/A**Verified Joint Fit-up:** Yes No N/A**Approved Drawings:** Yes No N/A**Approved WPS:** Yes No N/A**Delayed / Cancelled:** Yes No N/A**Bridge No:** 34-0006**Component:** OBG Mock-up shop**Summary of Items Observed:**

WELDING INSPECTION REPORT

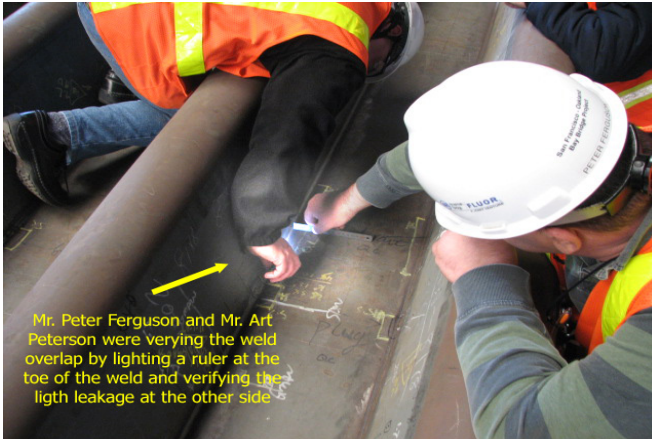
2 ZPMC visual weld inspection after welding the OBG Mock up Deck plate Section

The QA inspector observed that ZPMC QC inspector performed weld visual inspection to the OBG Mock-up deck plate section at the junction of the close ribs and deck plates (length of the U-ribs were approximately 13158 mm five (5) and 1750 mm five(5)). The QA inspector observed that the major weld discontinuities marked by ZPMC QC were as follow:

13 meters close ribs, Weld Overlap approximately 2500 mm of length at weld joint # 7, Incompleted fusion approximately 300 mm of length on weld # 4.

1.75 meters close ribs, 1200 mm weld overlap weld joint # 1
